KENNEBEC RIVER BASIN  
PITTSFIELD, MAINE

WAVERLY DAM  
ME 00111

PHASE I INSPECTION REPORT  
NATIONAL DAM INSPECTION PROGRAM

MAY 1981

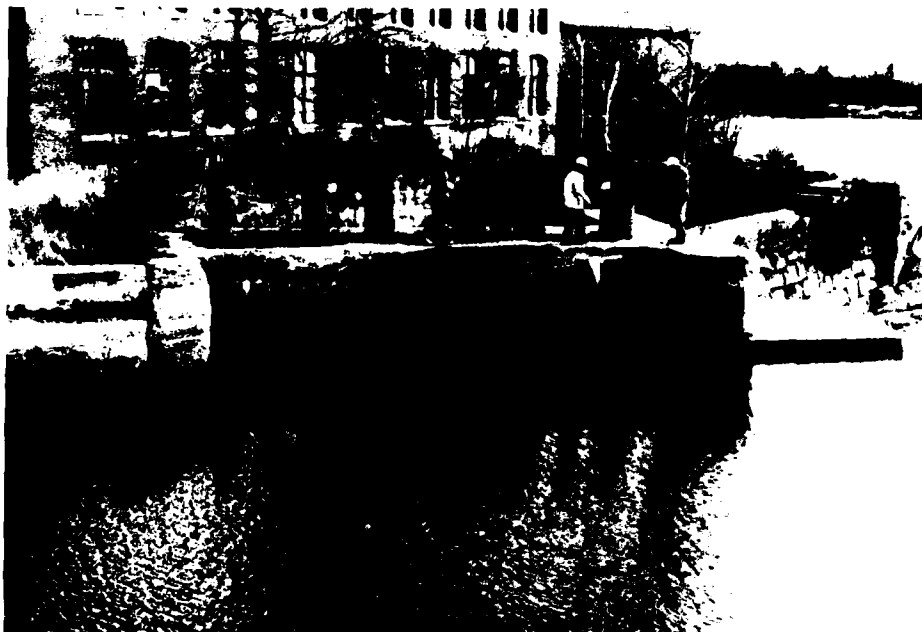
concrete faces of the intake structure were spalled, Photo Nos. 4 and 8, respectively, and had reinforcing steel visible.

4. Alignment at left end of dam, upstream

1. Repoint the spalled and cracked areas of the upstream retaining wall and intake structure at the left end of the dam.
2. Remove the tree and brush growth from the forebay and all other masonry walls.
3. Repair the cracks in the concrete of the outlet works training walls at the right end of the dam.
4. Prepare an operations and maintenance manual for the dam. The manual should include provisions for annual technical inspection by a qualified registered engineer and for round-the-clock surveillance of the dam during periods of high project discharge. The procedures should delineate the routine operational procedures and maintenance work to be done on the dam to ensure safe, satisfactory operation and to minimize deterioration of the facility.

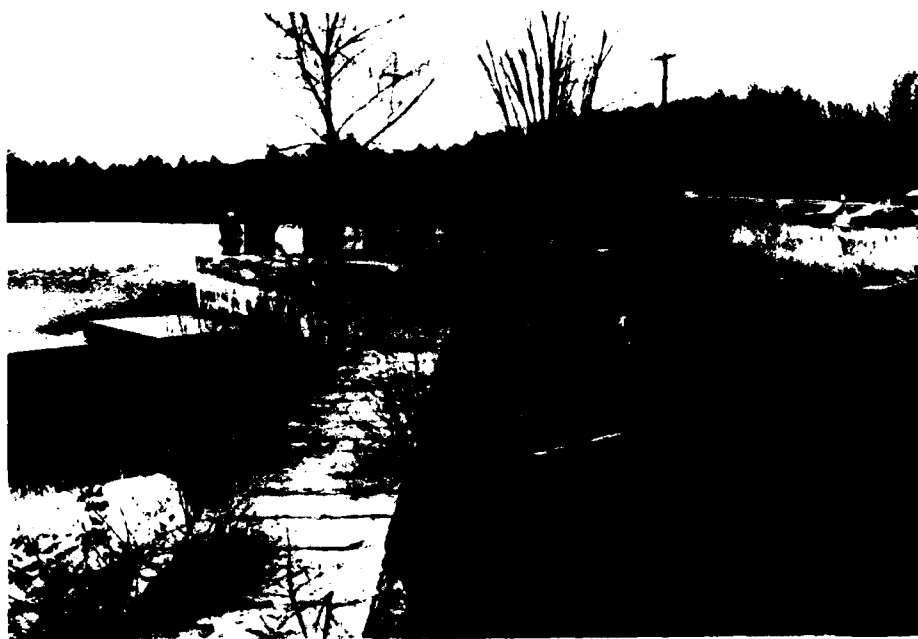
The stone masonry of the forebay was in fair condition with some loose joints and dislodged blocks, Photos No. 3 and 6. Trees and brush were growing from the forebay walls, Photo No. 5, with associated deterioration of the masonry. The forebay endwall, which houses two 8.7-ft. diameter steel penstock sections, Photo No. 3, was in fair condition.

6. Downstream side of intake structure at left end of dam

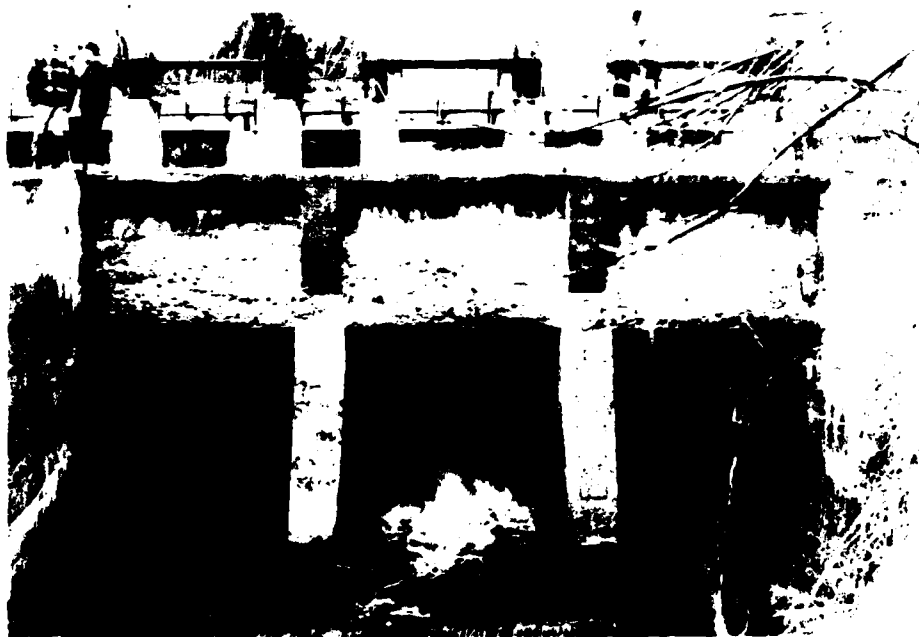
8. Interior of gate chambers at left end of dam

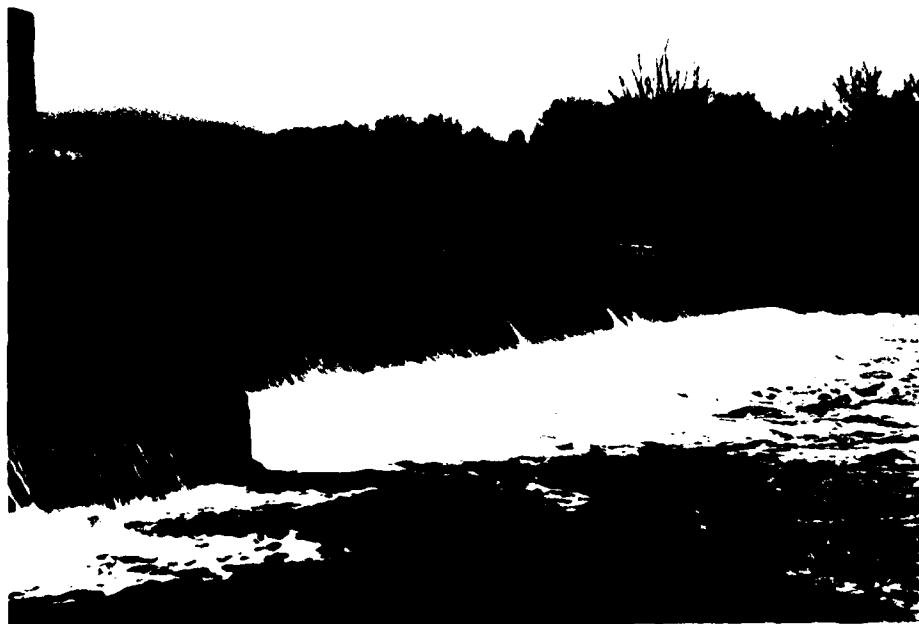
11. Horizontal alignment of spillway

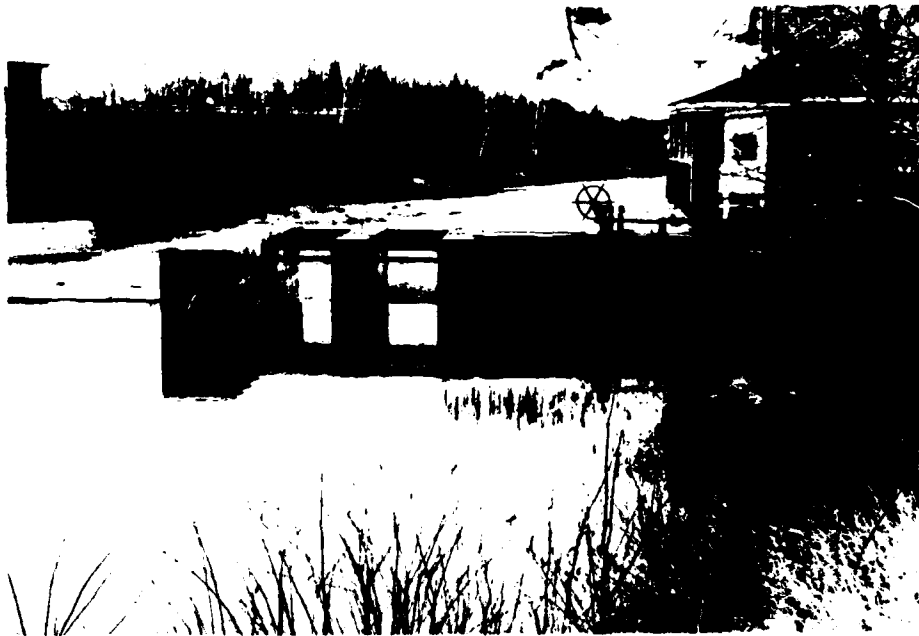
The two stoplog bays and two penstocks, located at the right side of the dam, were in good condition, Photo No. 12. The gate lift mechanisms were partially dismantled and not operable. Flow through one of the penstocks, Photo No. 13, indicated leakage through the corresponding slide gate. The gate chamber training walls were cracked at the top, Photo No. 14, where steel members were embedded in the concrete. These steel members supported walkway gratings at some previous time.

12. Alignment at right end of dam
